hydraulic servo units

The Mk 2A Hydraulic Servo unit and Powerstop has been completely superseded by the Mk 2B unit. To save space therefore this manual page does not describe and illustrate how the unit works, but does provide the necessary Servicing, Testing and Fault Finding information.

This manual page deals with the Mk 11B Hydraulic Servo Unit and Powerstop, which superseded the Mk 11A. The external differences between the two units can be seen from the illustration (Fig. 1). Internally the basic design is unchanged but small improvements have been made and these are (1) operational 'clonk' has been eliminated by the anti-knock output piston, (2) the vacuum piston has been replaced by a diaphragm and; (3) the vacuum connection is now in the vacuum chamber and not the hydraulic body. The design of the vacuum chamber and the retaining band, which holds the two halves of the shell together, makes the outside shape slightly different but, with few exceptions it is expected the Mk 11B unit will eventually replace the Mk 11A in service.

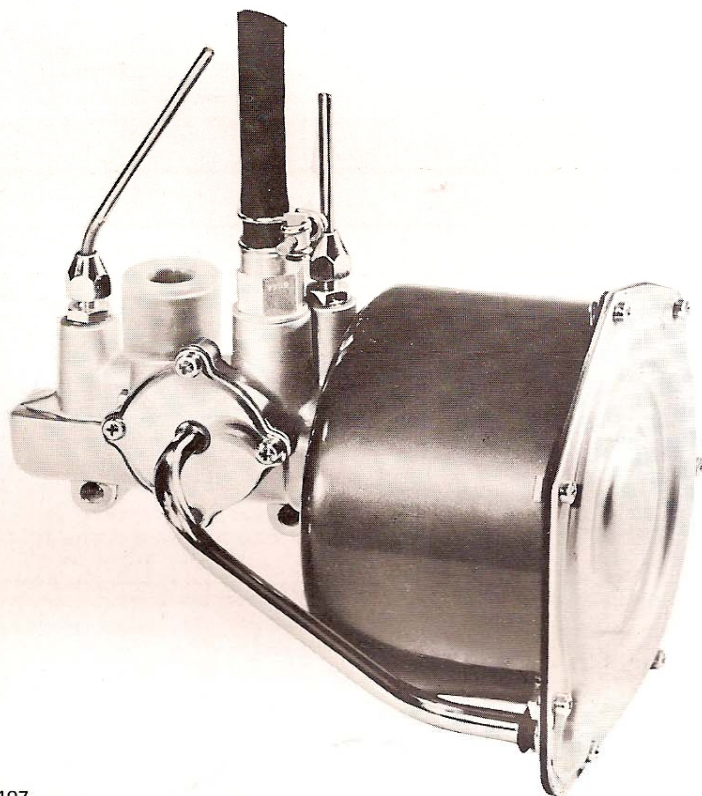
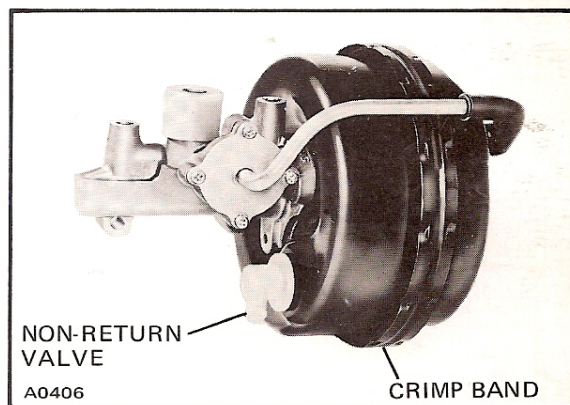
1 MK 2A SERVO UNIT

When replacing a Mk 2A unit with a Mk 2B unit, as the illustration shows, the two units are slightly different in shape and therefore minor modifications may be necessary on some installations. The changes fall into two categories:-

The vacuum hose connection on Mk 2B units is in the vacuum shell and not, as with Mk 2A in the hydraulic body. It is therefore expected that the vacuum hose will need to be longer. A longer length of hose than the one originally fitted should therefore be obtained from your Girling distributor.

Because the crimp band makes the Mk 2B unit slightly bigger overall, modifications may be necessary on some installations. In some cases, the fitting of spacers between the unit and brackets, would make alterations to the brackets unnecessary.

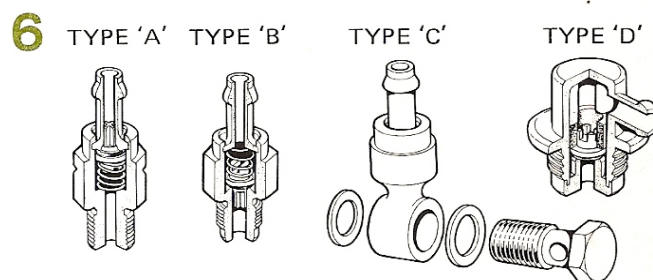
in the tank or servo unit so that power operation of the brakes is possible for a limited period, should a vacuum failure occur. Fig. 6 shows the types of non-return valves in use: Type 'A' screws directly into the engine manifold; Types 'B' and 'C' are usually fitted in the servo body of Mk 11A units; and Type 'D' which is a push fit in the rear shell of the unit and may have a straight or right angled nozzle. Type 'D' is white in colour so that it can be distinguished from the slave adaptor coloured red. If a red slave adaptor is fitted in the rear shell instead of a white type 'D' non-return valve, a non-return valve must be fitted at some other point in the vacuum line.

Type 'A' works in the opposite way to types 'B', 'C' and 'D' as the half ball, or plate valve, is in the opposite end of the valve body. The illustration shows the arrangement of the internal parts of types 'A' and 'B', and also shows the 'V' cuts in the hexagon body which identify type 'A'.

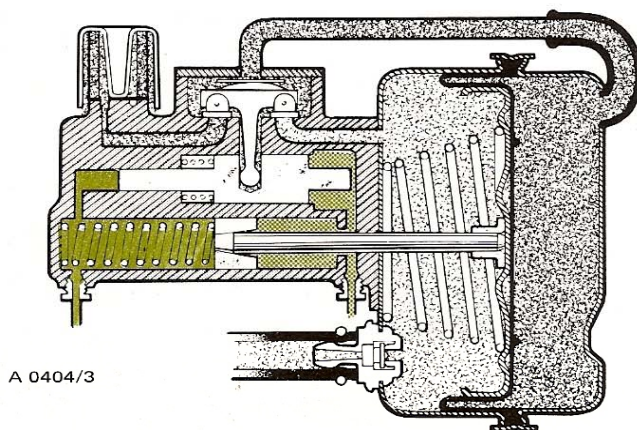
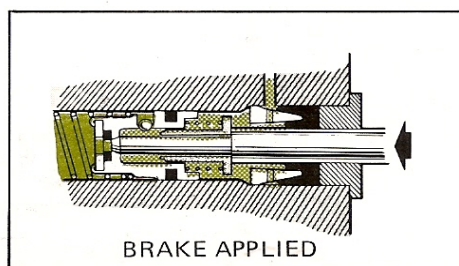
4 BRAKE HELD ON

If the force on the pedal is increased after arriving at the position shown on Fig. 4, the valve gear operates to give additional assistance from the diaphragm until the thrust on each end of the control piston is balanced or until the limit of available vacuum is reached. Conversely, if the foot pedal force is reduced the valve gear operates to reduce the pressure at the brake cylinders until again, a state of balance of the control piston is reached. The difference in area between the two opposed ends of the control piston determines the proportion of assistance provided by the unit. If, for example, the large end is twice the area of the small end, the hydraulic pressure output is built up to twice that of the input from the master cylinder before the control piston moves back to close the air valve. Such a unit therefore would have an output of twice the pressure of the input, throughout the range of the unit.

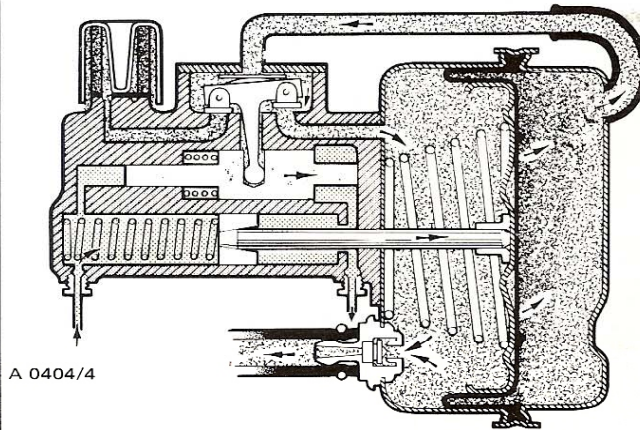
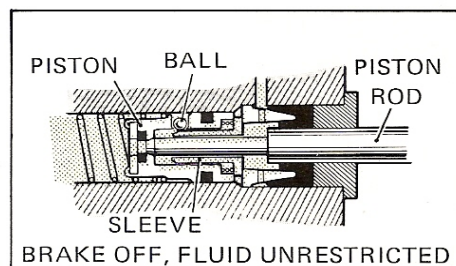
5 BRAKE RELEASED

returns and with it the output piston, relieving the pressure to the wheel cylinders as shown on Fig. 5. The piston sleeve lifts the ball and allows the fluid to move unrestricted between the supply tank and wheel cylinders.

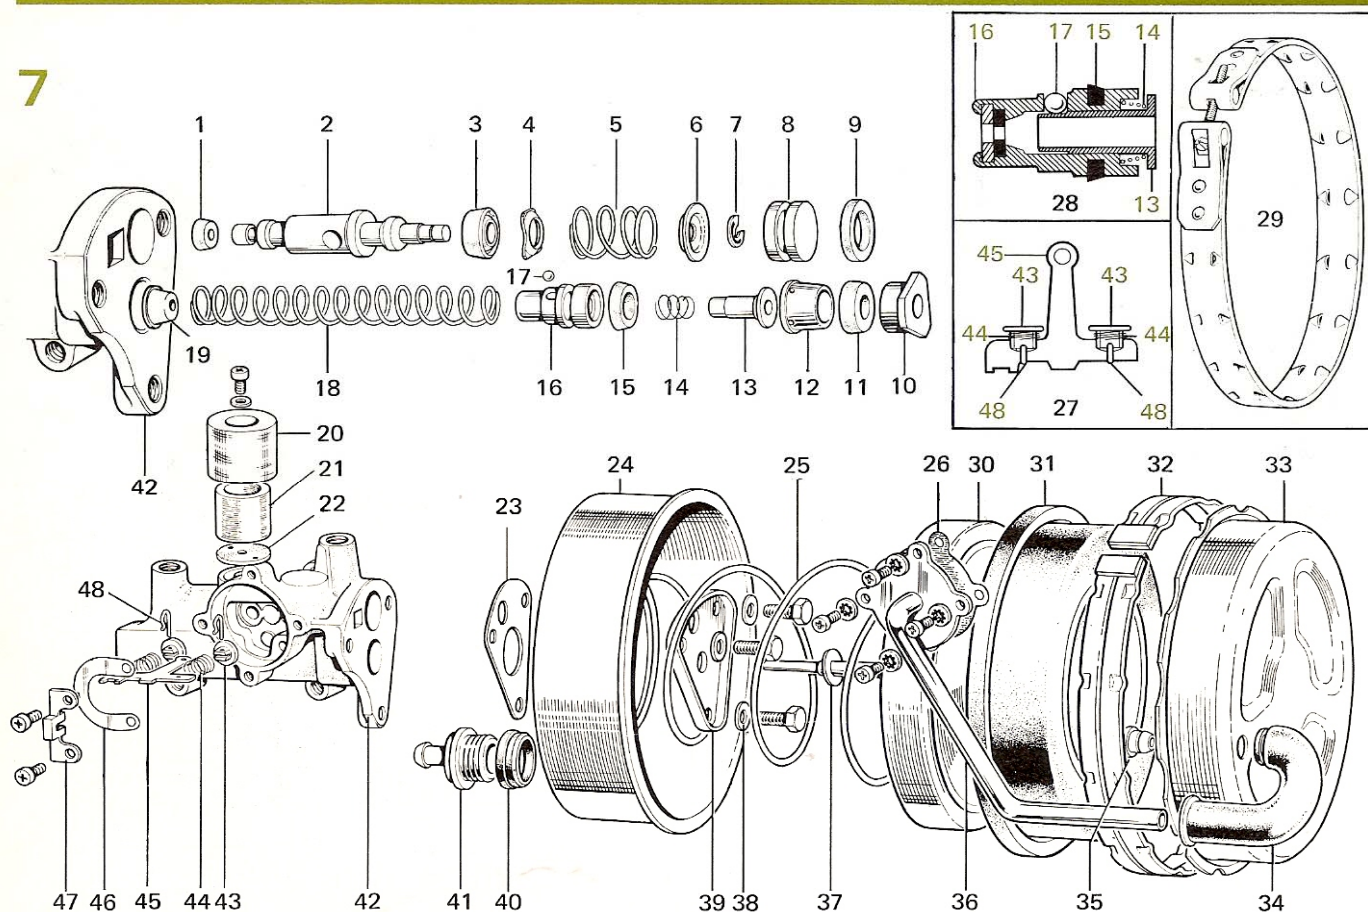
7

Listed below are the kits available to service the unit; the relevant parts contained in each kit can be seen on the illustration (Fig. 7).

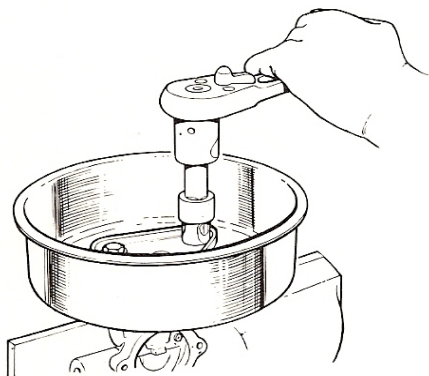
13

Re-position the unit in vice (Fig. 13) and unscrew the three bolts retaining the rear shell to the body. Remove the clamping plate with care as the output piston spring may eject the parts from the bore. If the parts are not ejected, withdraw the bush and hook out the piston rod gland seal when the output piston spring will then eject the anti-knock output piston, piston sleeve spring and ball; but provided care is used these parts will be caught in the rear shell..

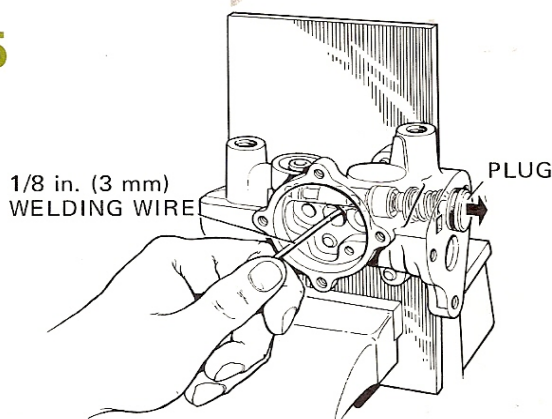
15

Insert a suitable bent rod into the hole in the control piston and lever the piston along to push out the plug (Fig. 15). Remove the control piston from the bore and compress the spring to remove the circlip, retainer and spring abutment. Remove the seals from the plug and control piston.

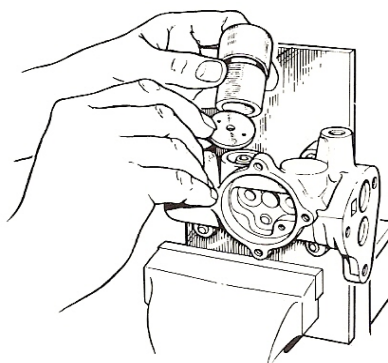
16

Unscrew the setscrew and remove the air filter and associated parts (Fig. 16).

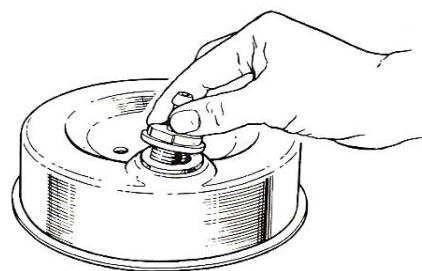
19

Fit the non-return valve/adaptor grommet (Fig. 19) to the rear shell. Lubricate the ribs of the non-return valve/adaptor with Girling Grease No. 64949009 and push fully home in the grommet.

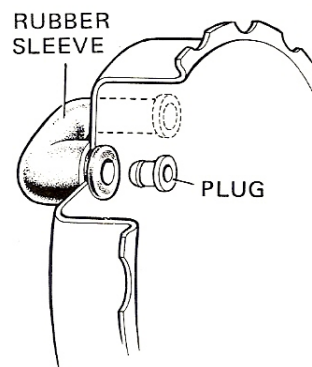
20

Fit the rubber sleeve to the front shell (Fig. 20) lubricate the plug with Girling Grease No. 64949009 and insert as shown.
